Collapse of old stone barn wall at Camp Michaux, 2016

**I first noticed it on Tuesday morning, February 2, 2016
(it probably fell the night before)**

Andre Weltman
Friends of Pine Grove Furnace State Park

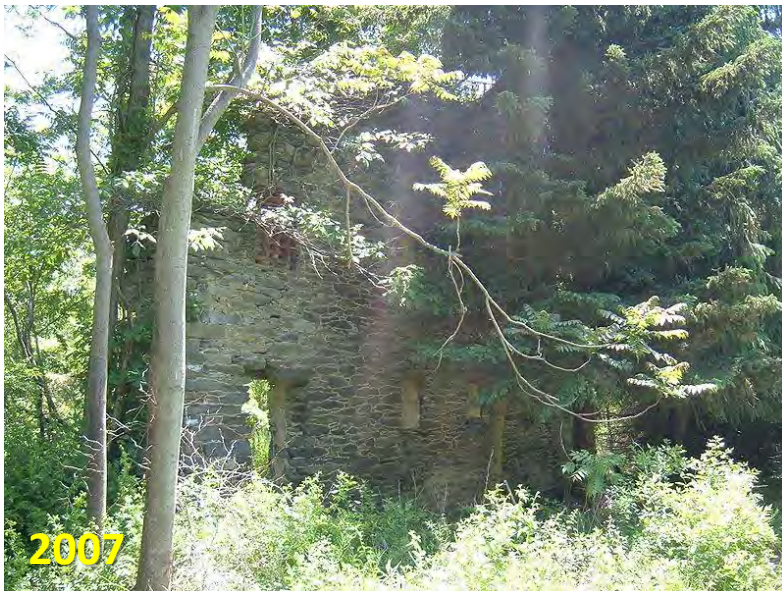
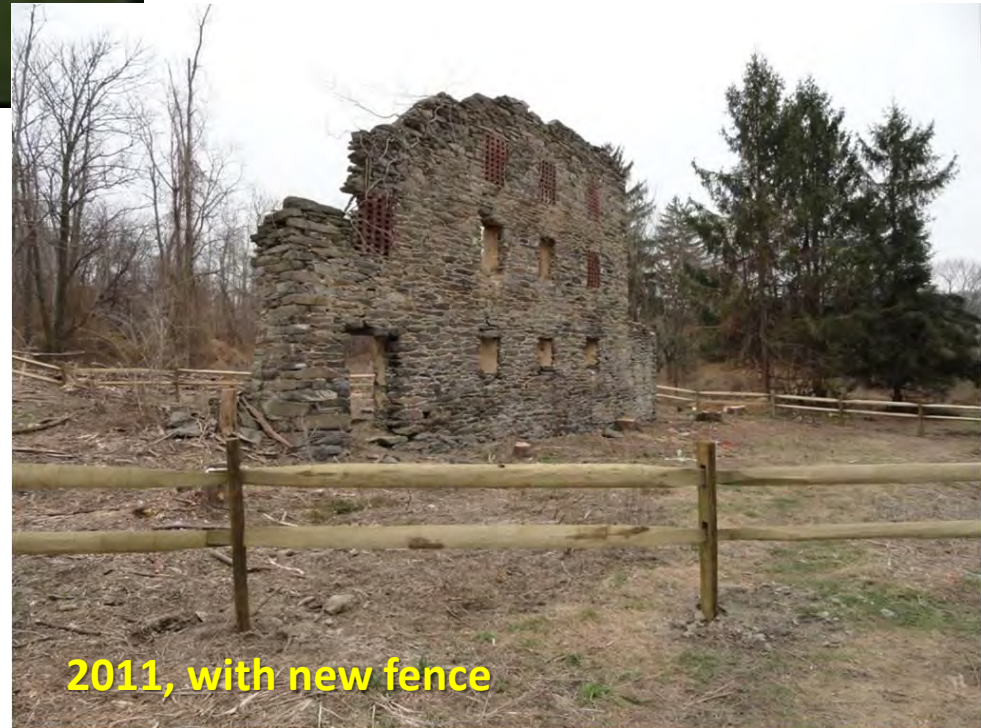
Previous views of the barn wall

Three large trees grew in front of it between the 1960s and 2000s, but were carefully cut down by DCNR in 2011 when the split rail fence was installed to protect passersby.

The Appalachian Trail used to pass directly in front of the structure but was re-routed a few years ago.

estimated height in 2009 by
photometric technique: 20 feet

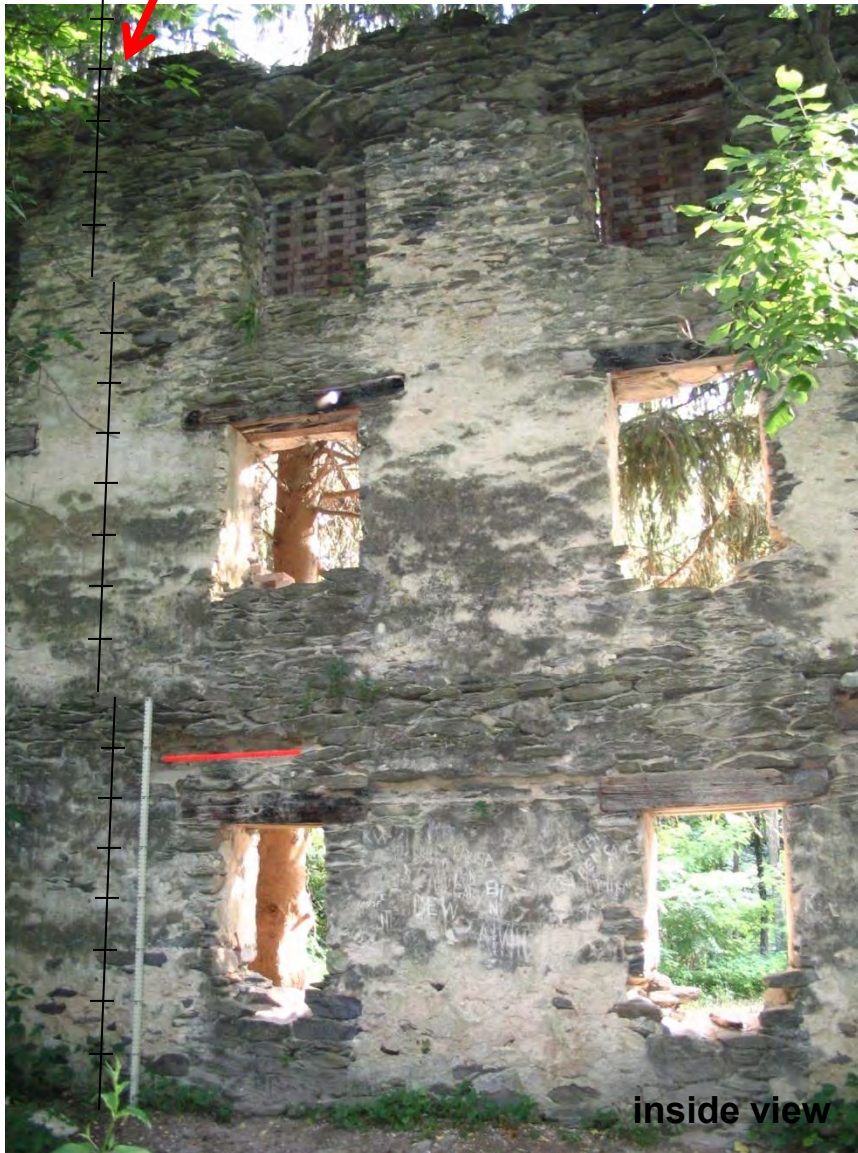
inside view

To measure extent
of leaning, Andre
Weltman tossed a
rope over the top
in 2009 ...

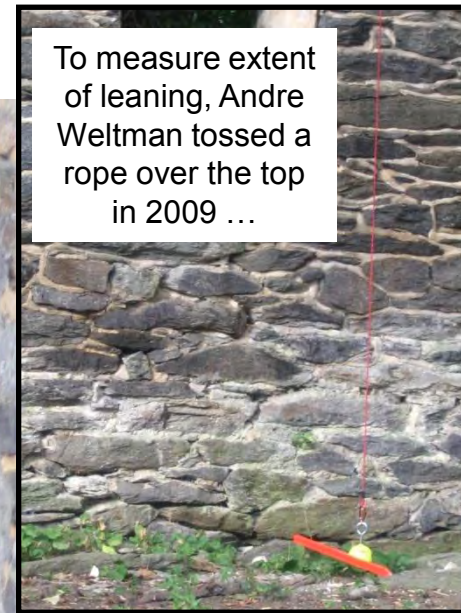
...and found that the
top was overhanging
the base by 19 inches

(leaning towards the A.T. which
passed in front of it at the time)

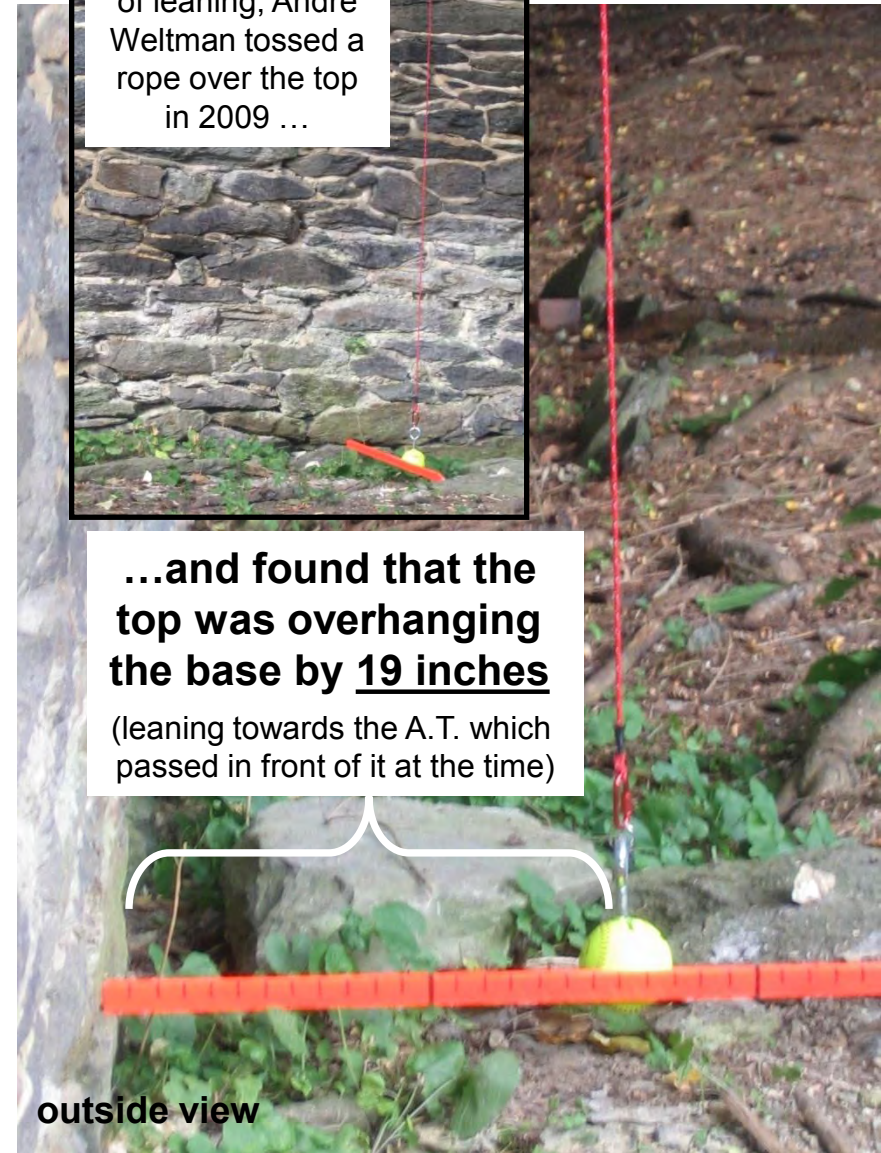
outside view

This freestanding masonry remnant of an 18th century barn was badly leaning & curving outward. Left by itself, collapse was inevitable. Recent snowfall and freeze-thaw cycles likely contributed.

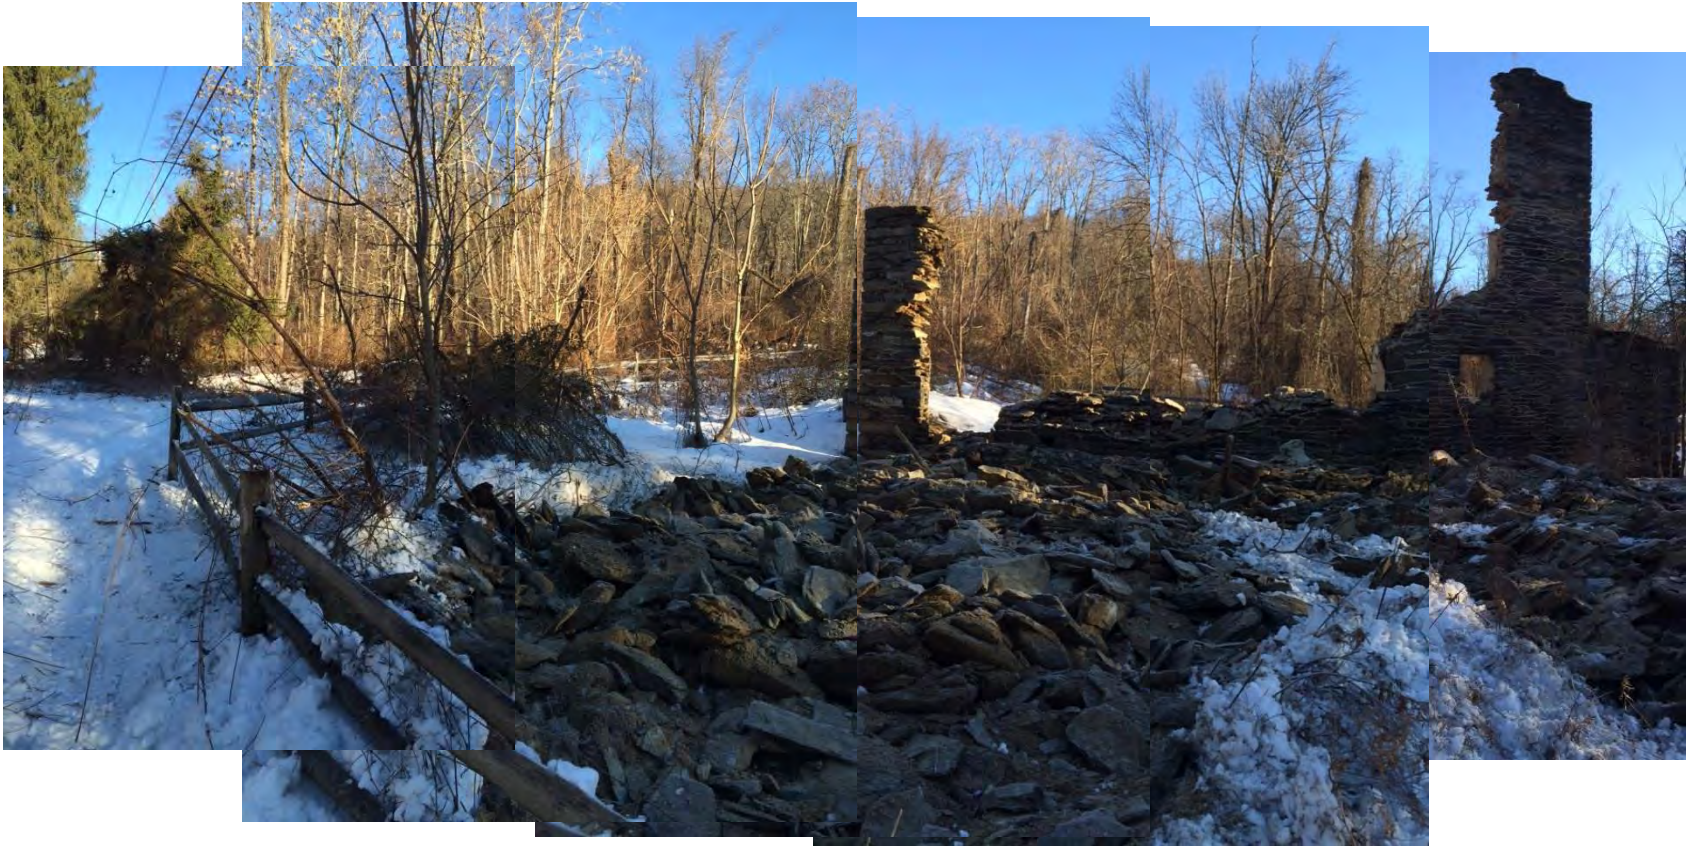
Note that stones fell *exactly* as far as the front inside edge of the split rail fence.

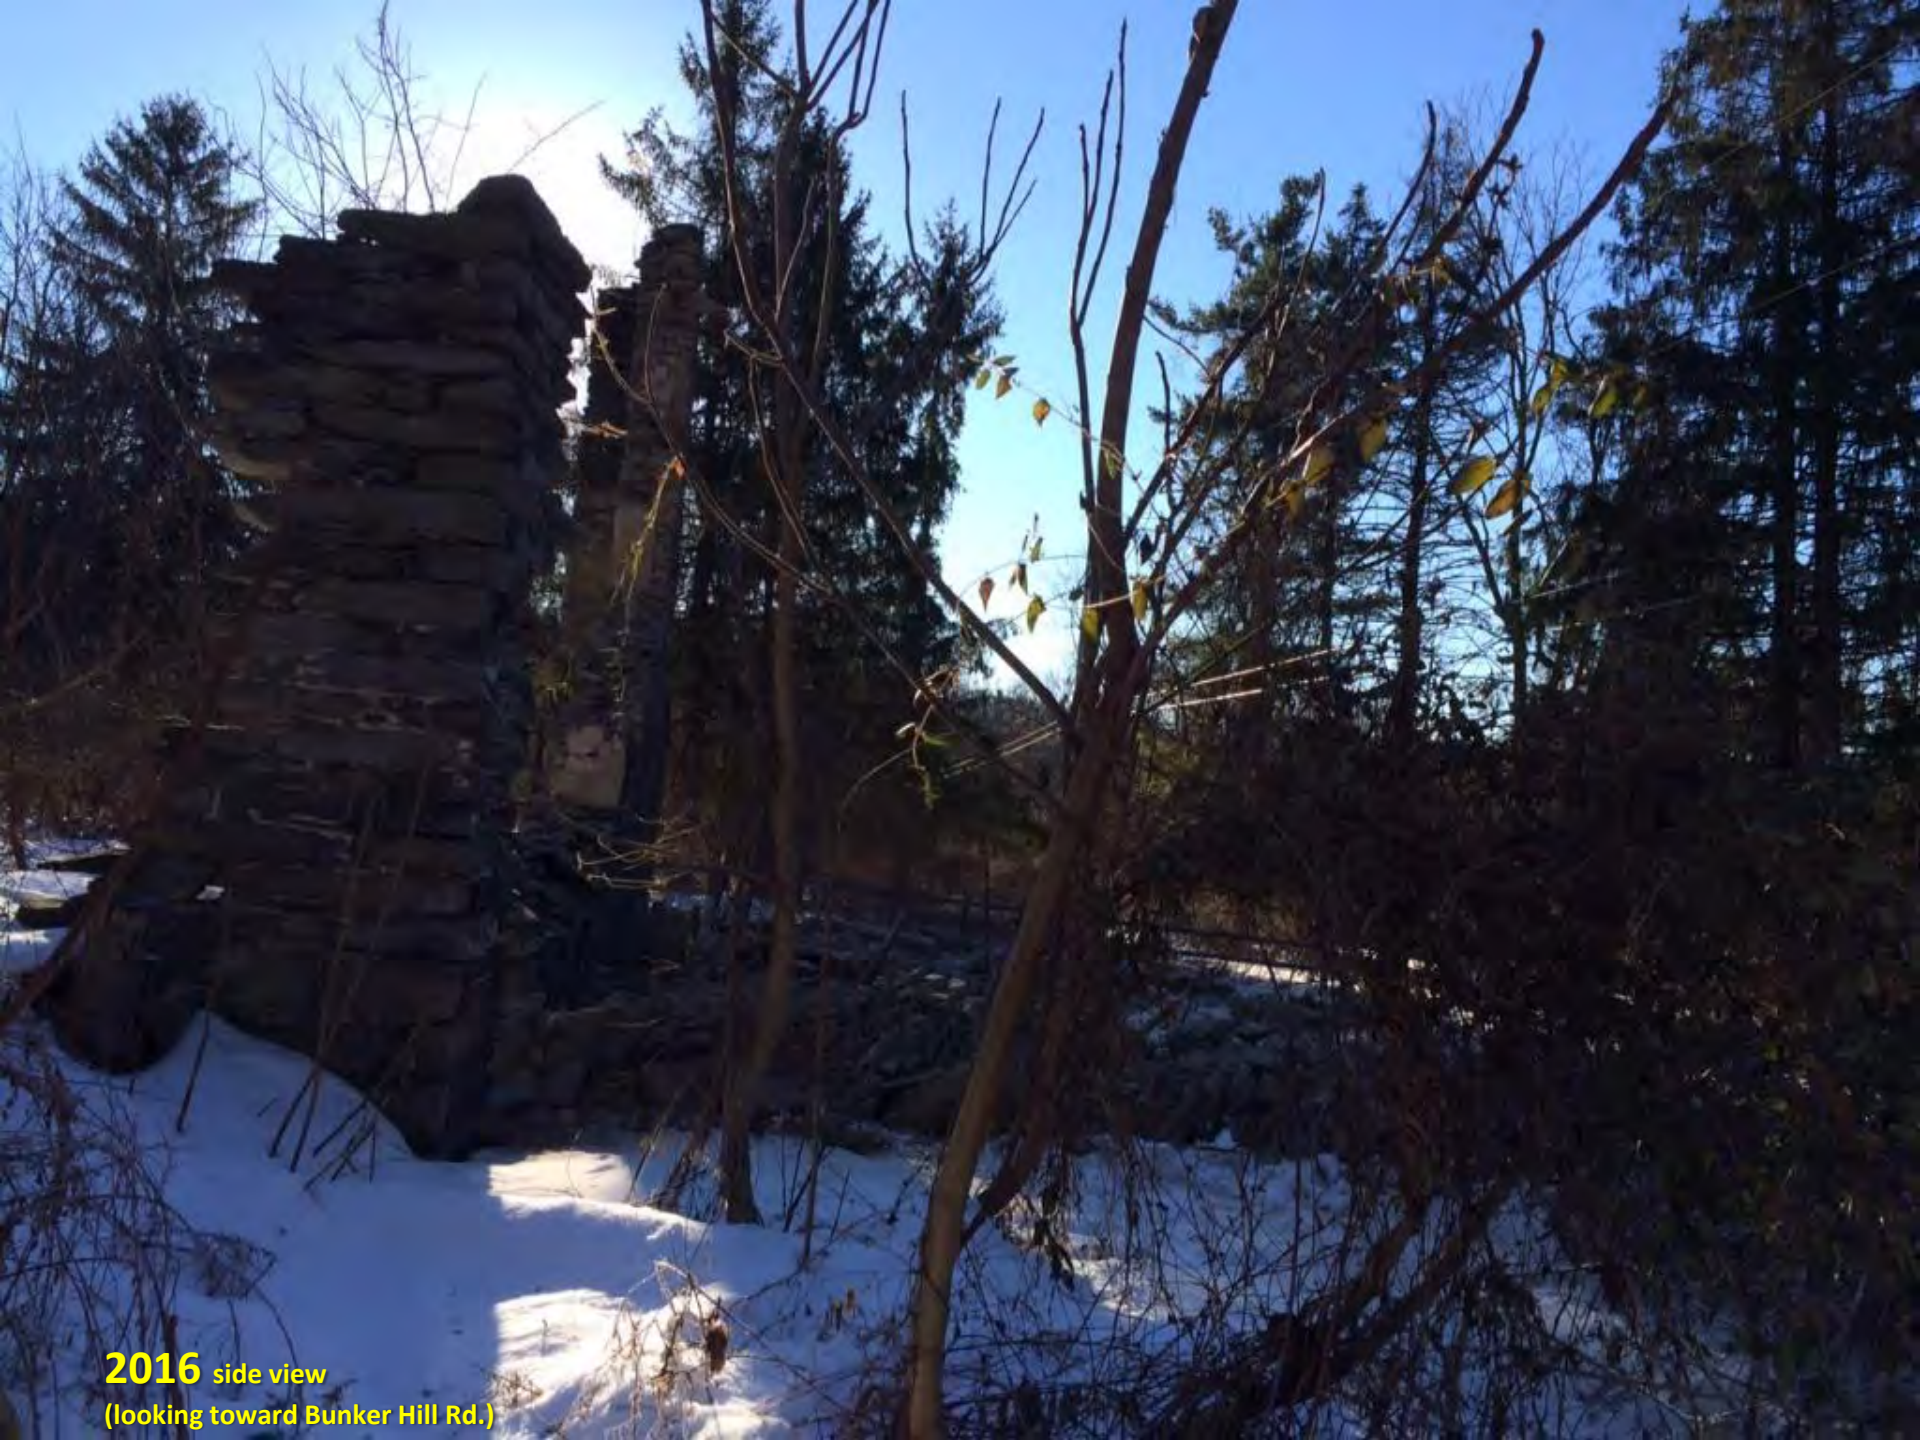
2016 side view
(looking toward Bunker Hill Rd.)

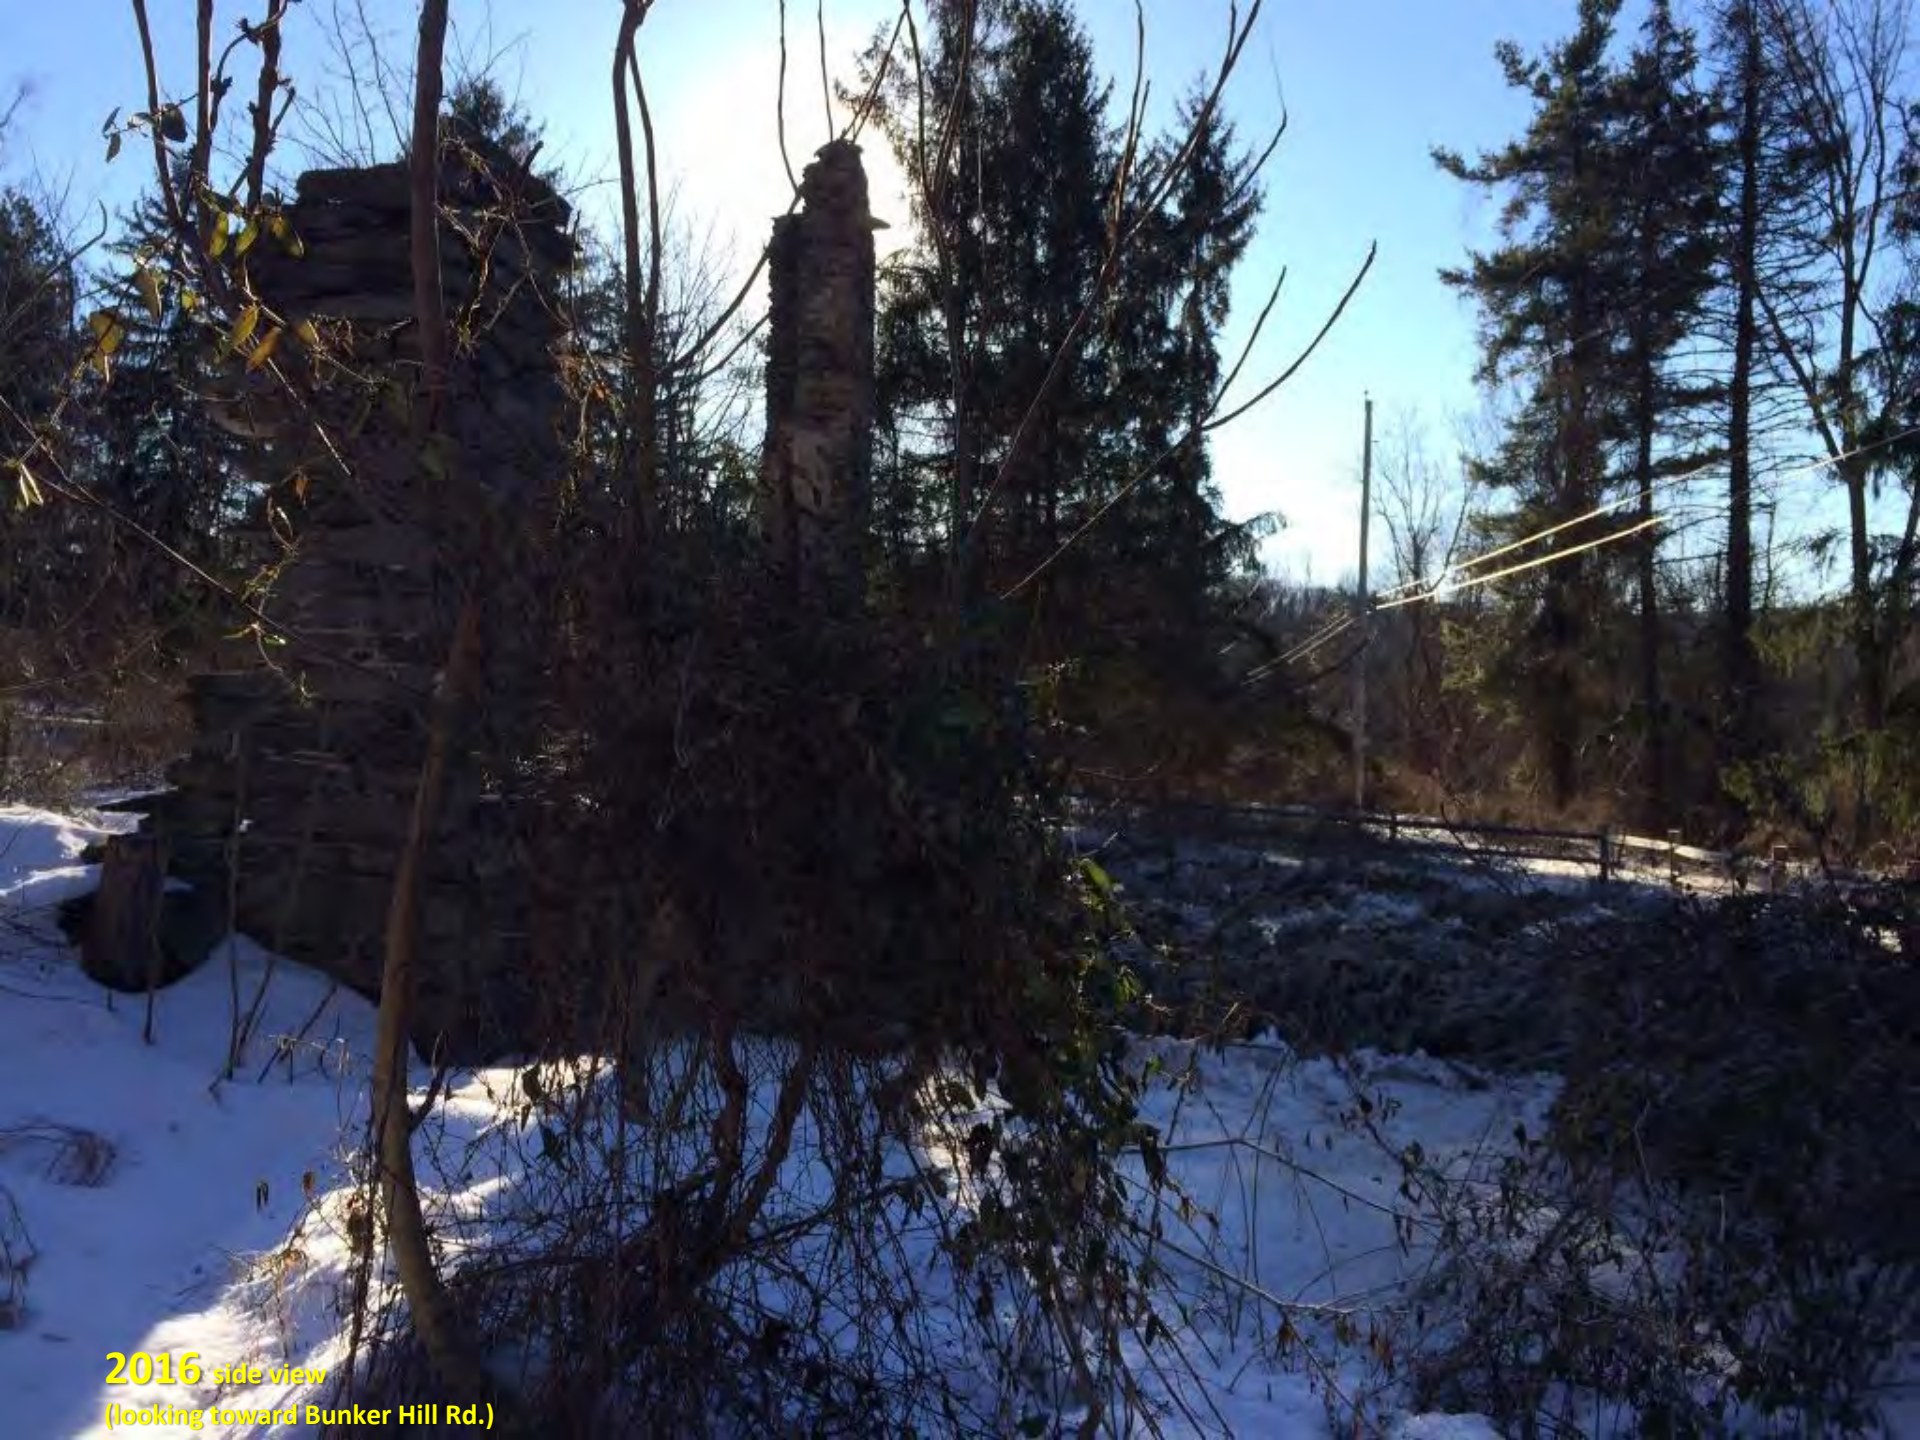
2016 side view
(looking toward Bunker Hill Rd.)
